Manhole Inspection Summary

Manhole # S25II_039MH

Insp Date: **8/29/07 9:56 AM**

Location Address: **2027 DRUID HILL AVE**

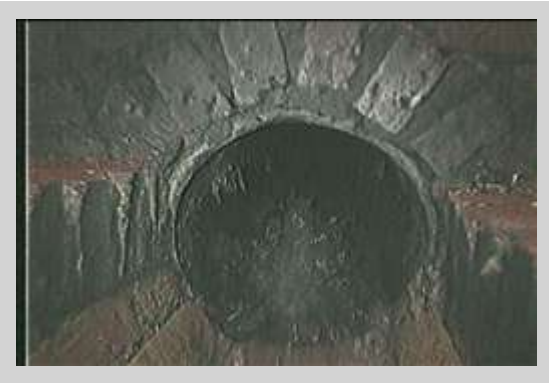
10 in. Circular Gravity Sewer Pipe Out @ 12 O'Clock

Pipe Material: **Clay** ☐ Pipe Lined

Invert Depth: **12.20** (ft.) Flow Characteristics: **Fast**

Infiltration: **None** Pipe Seal Cond: **Unknown**

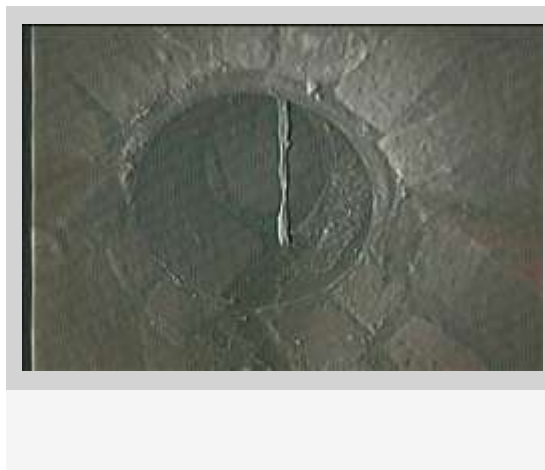
Drop In @ 8 O'Clock

Pipe Material: **Clay**

Infiltration: **Evidence**

Drop Condition: **Open**
